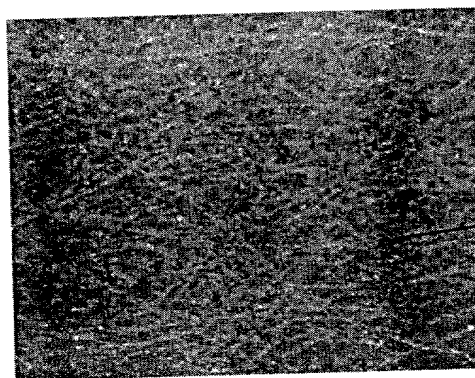
Fig. 4 The covered stent's surface shows micropores (~15-25 μm) in the polymer stretched between the covered struts of the metallic stent.

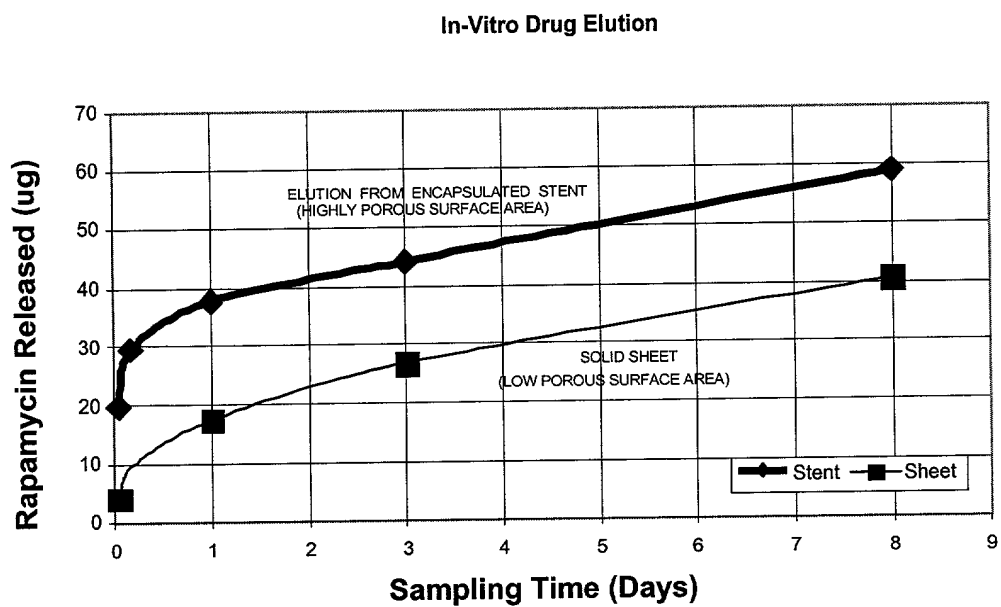
Fig. 5

Fig. 6 In-Vitro Elution Characteristics of Rapamycin in Serum, measured by HPLC .
